Ratna razaranja spomeničke baštine u Dubrovniku i okolici

War Damage to Cultural Monuments in Dubrovnik and its Surroundings

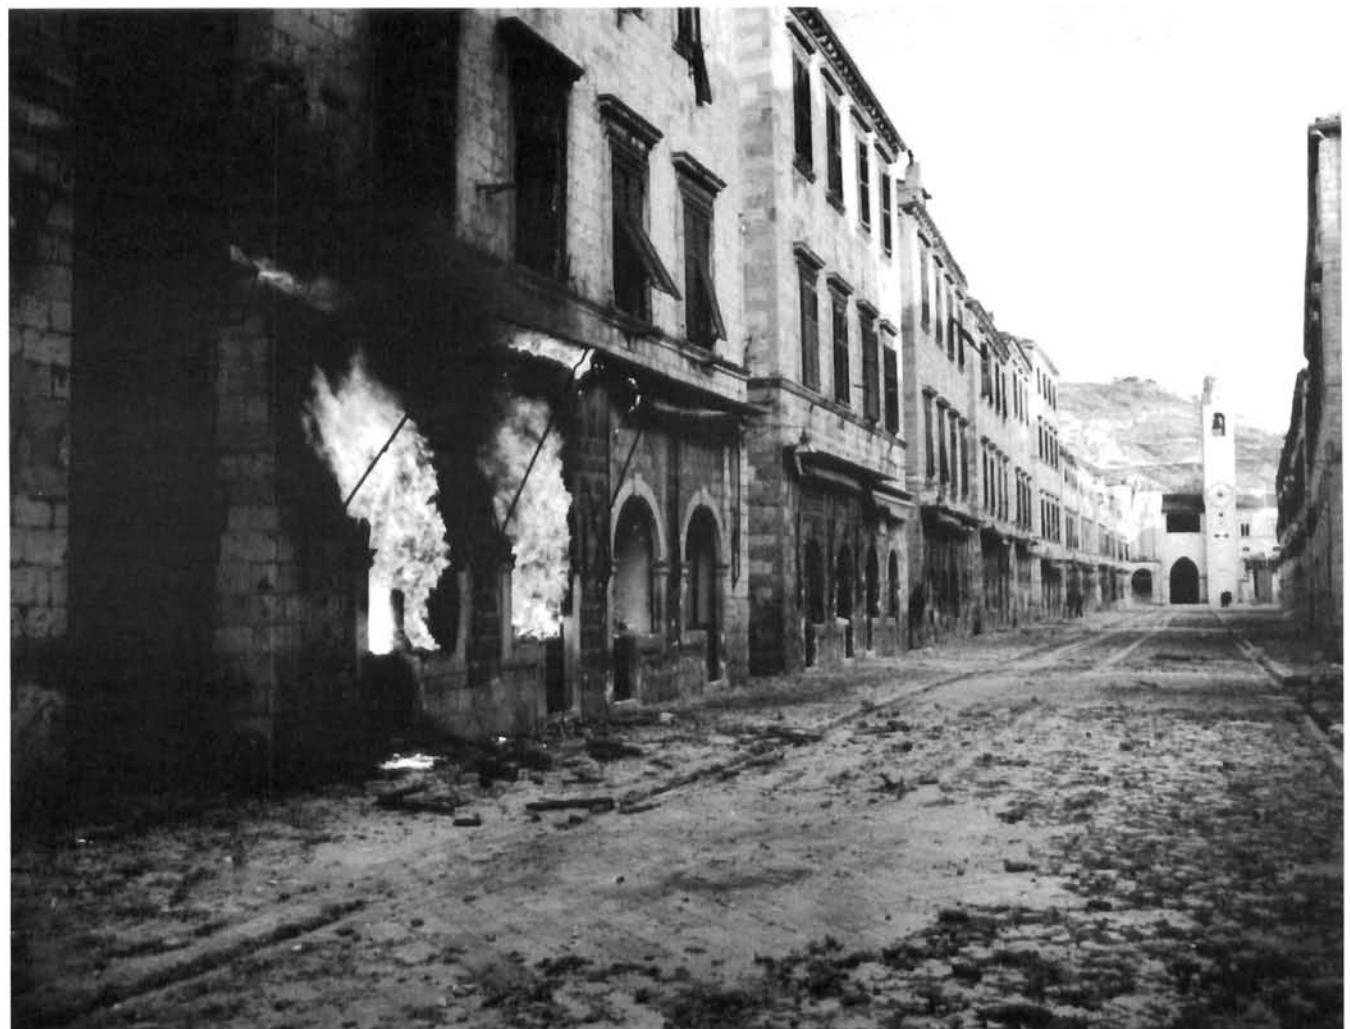
Placa 6. prosinca 1991. (foto: Božidar Gjukić)
Placa, 6 December 1991 (Photo: Božidar Gjukić)

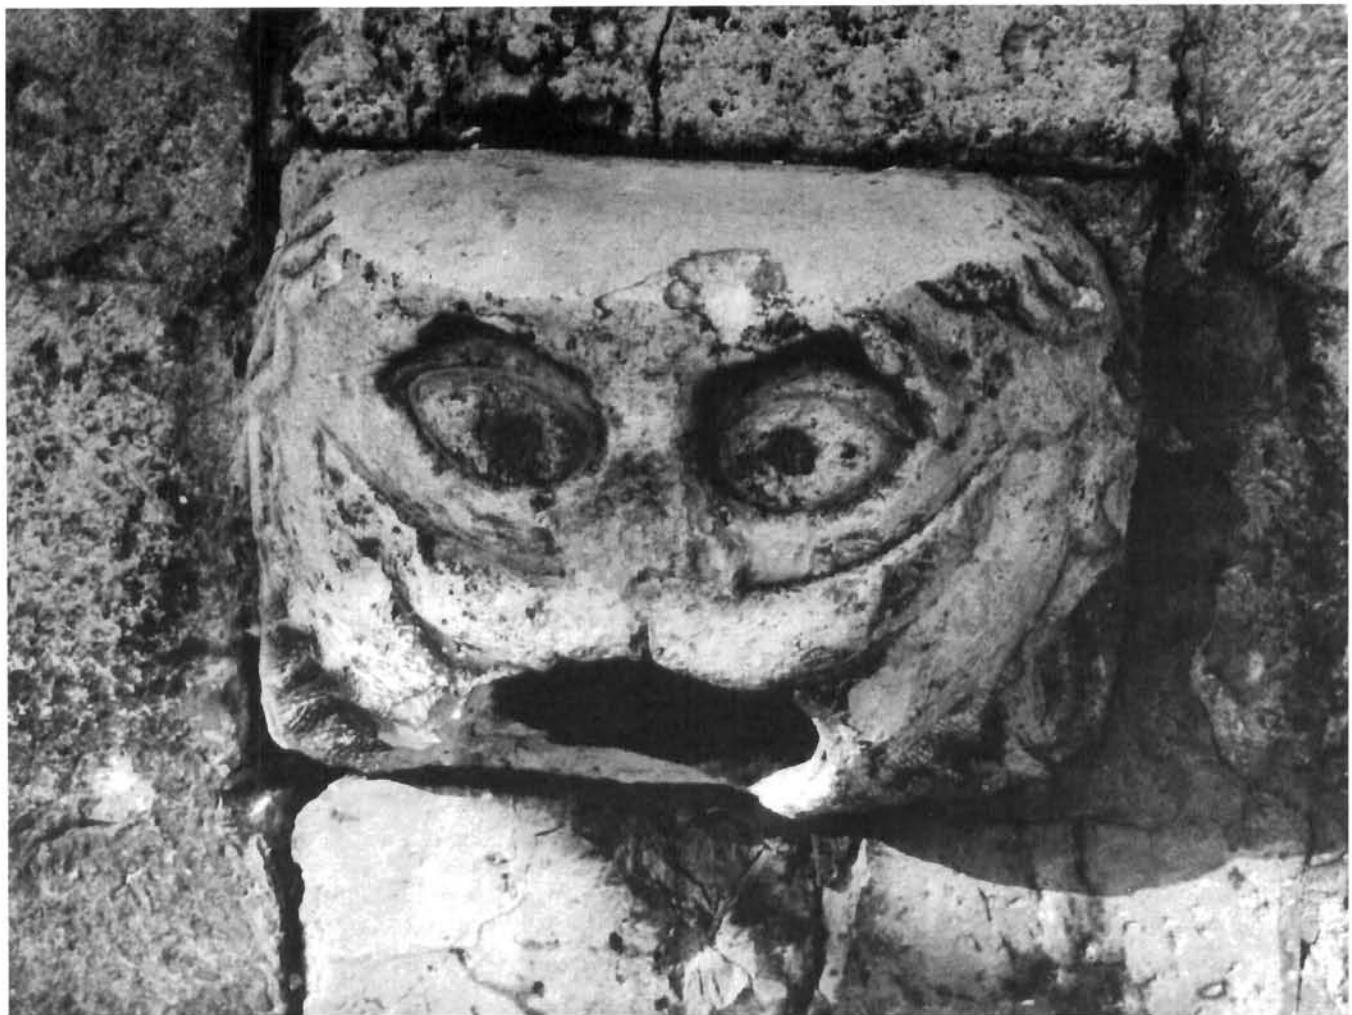
Pročelje crkve Franjevačkog samostana, točak (foto: Božidar Gjukić)
Facade of the church in the Franciscan monastery, a detail (Photo: Božidar Gjukić)

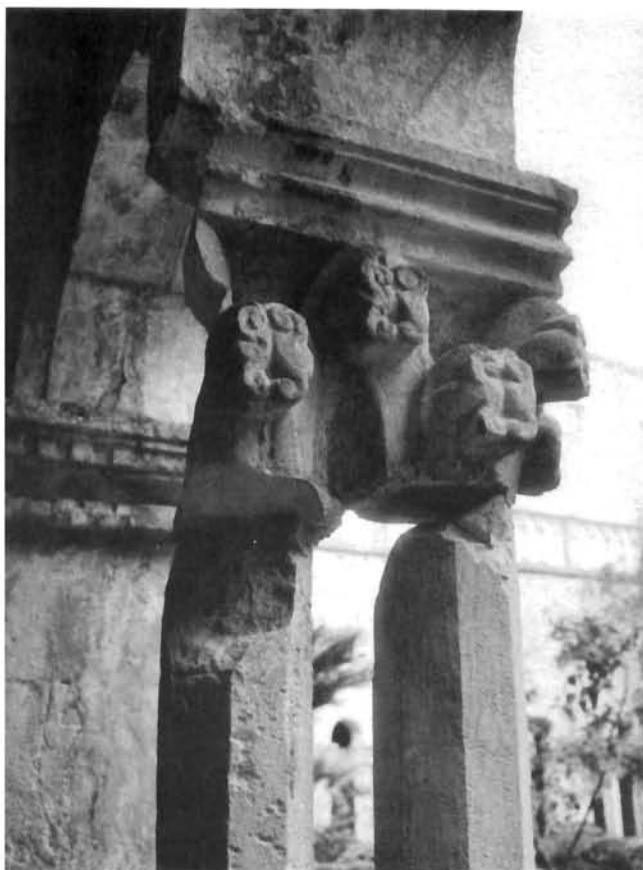
Franjevački samostan, heksafora klaustra (foto: Božidar Gjukić)
Franciscan monastery, hexafora in the cloister (Photo: Božidar Gjukić)

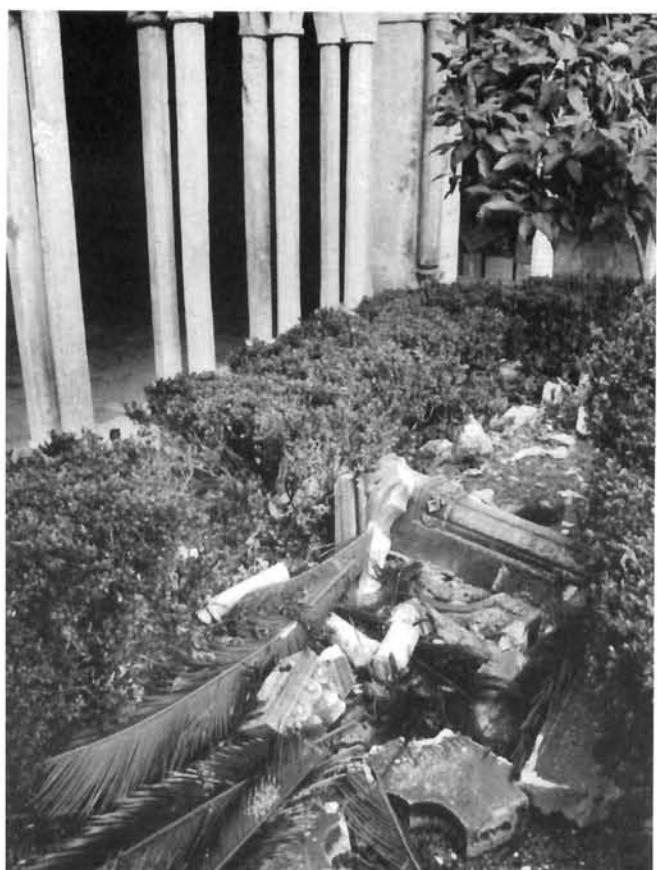
Franjevački samostan, dvorište klaustra (foto: Božidar Gjukić)
Franciscan monastery, courtyard in the cloister (Photo: Božidar Gjukić)

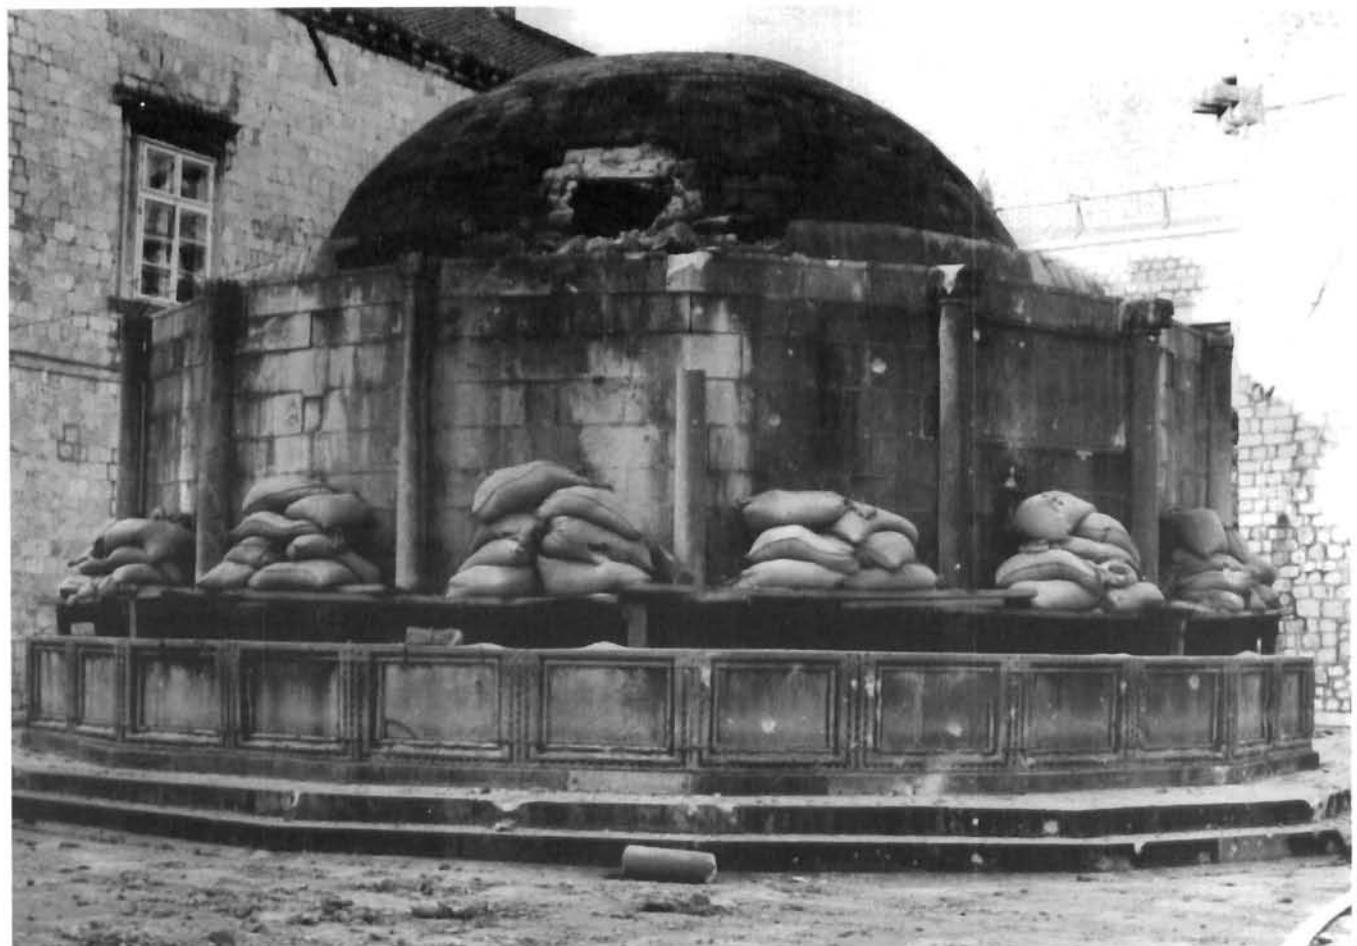
Velika Onofrijeva fontana (foto: Miljenko Mojaš)
Onofrio's Great Fountain (Photo: Miljenko Mojaš)

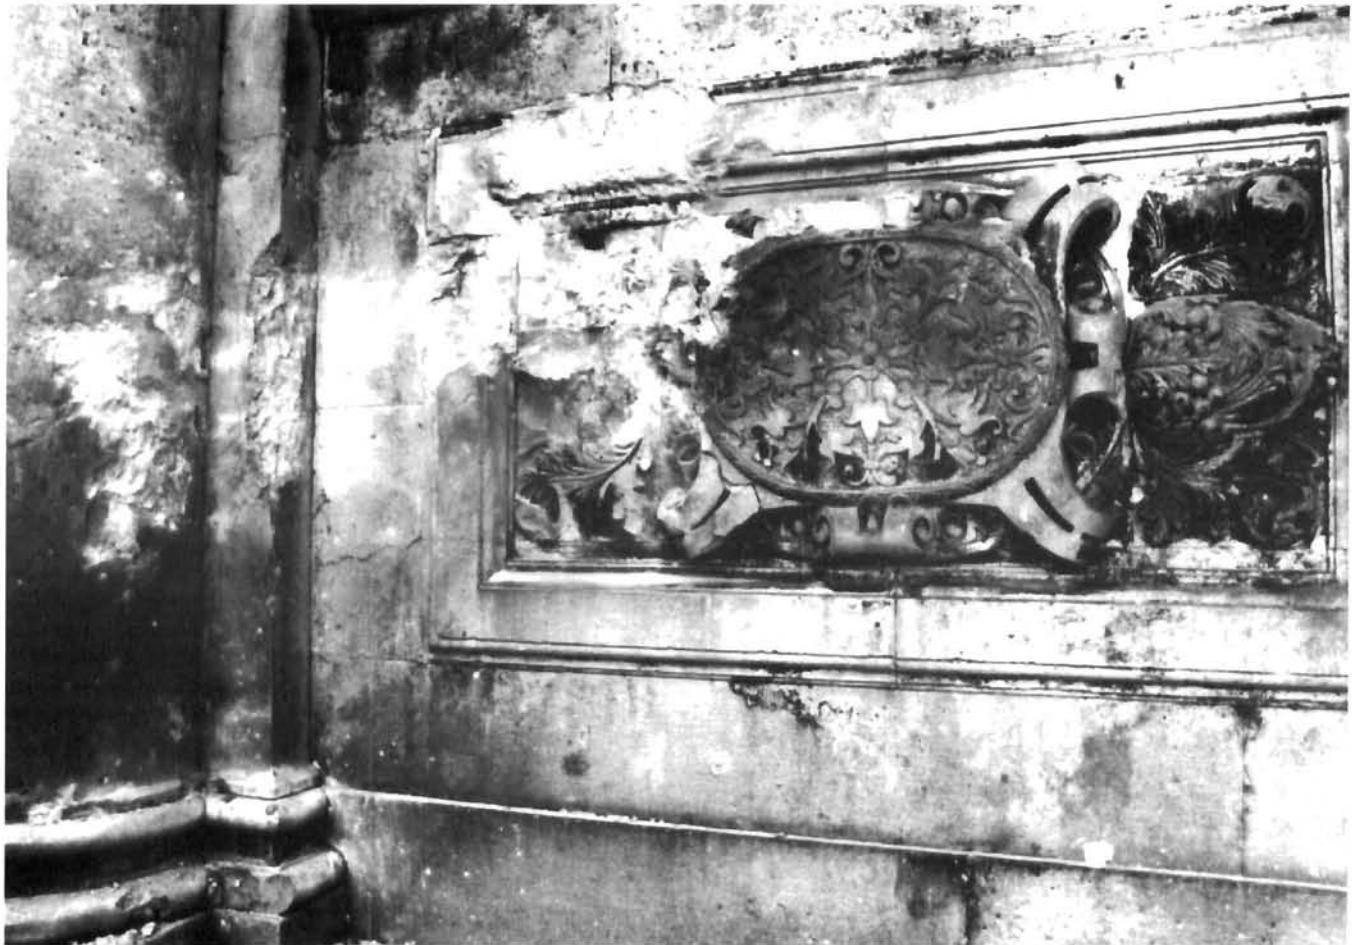
Crkva sv. Vlaha, istočna kartuša pročelja (foto: Miljenko Mojaš)
Church of St. Blasius, cartouche on the east front (Photo: Miljenko Mojaš)

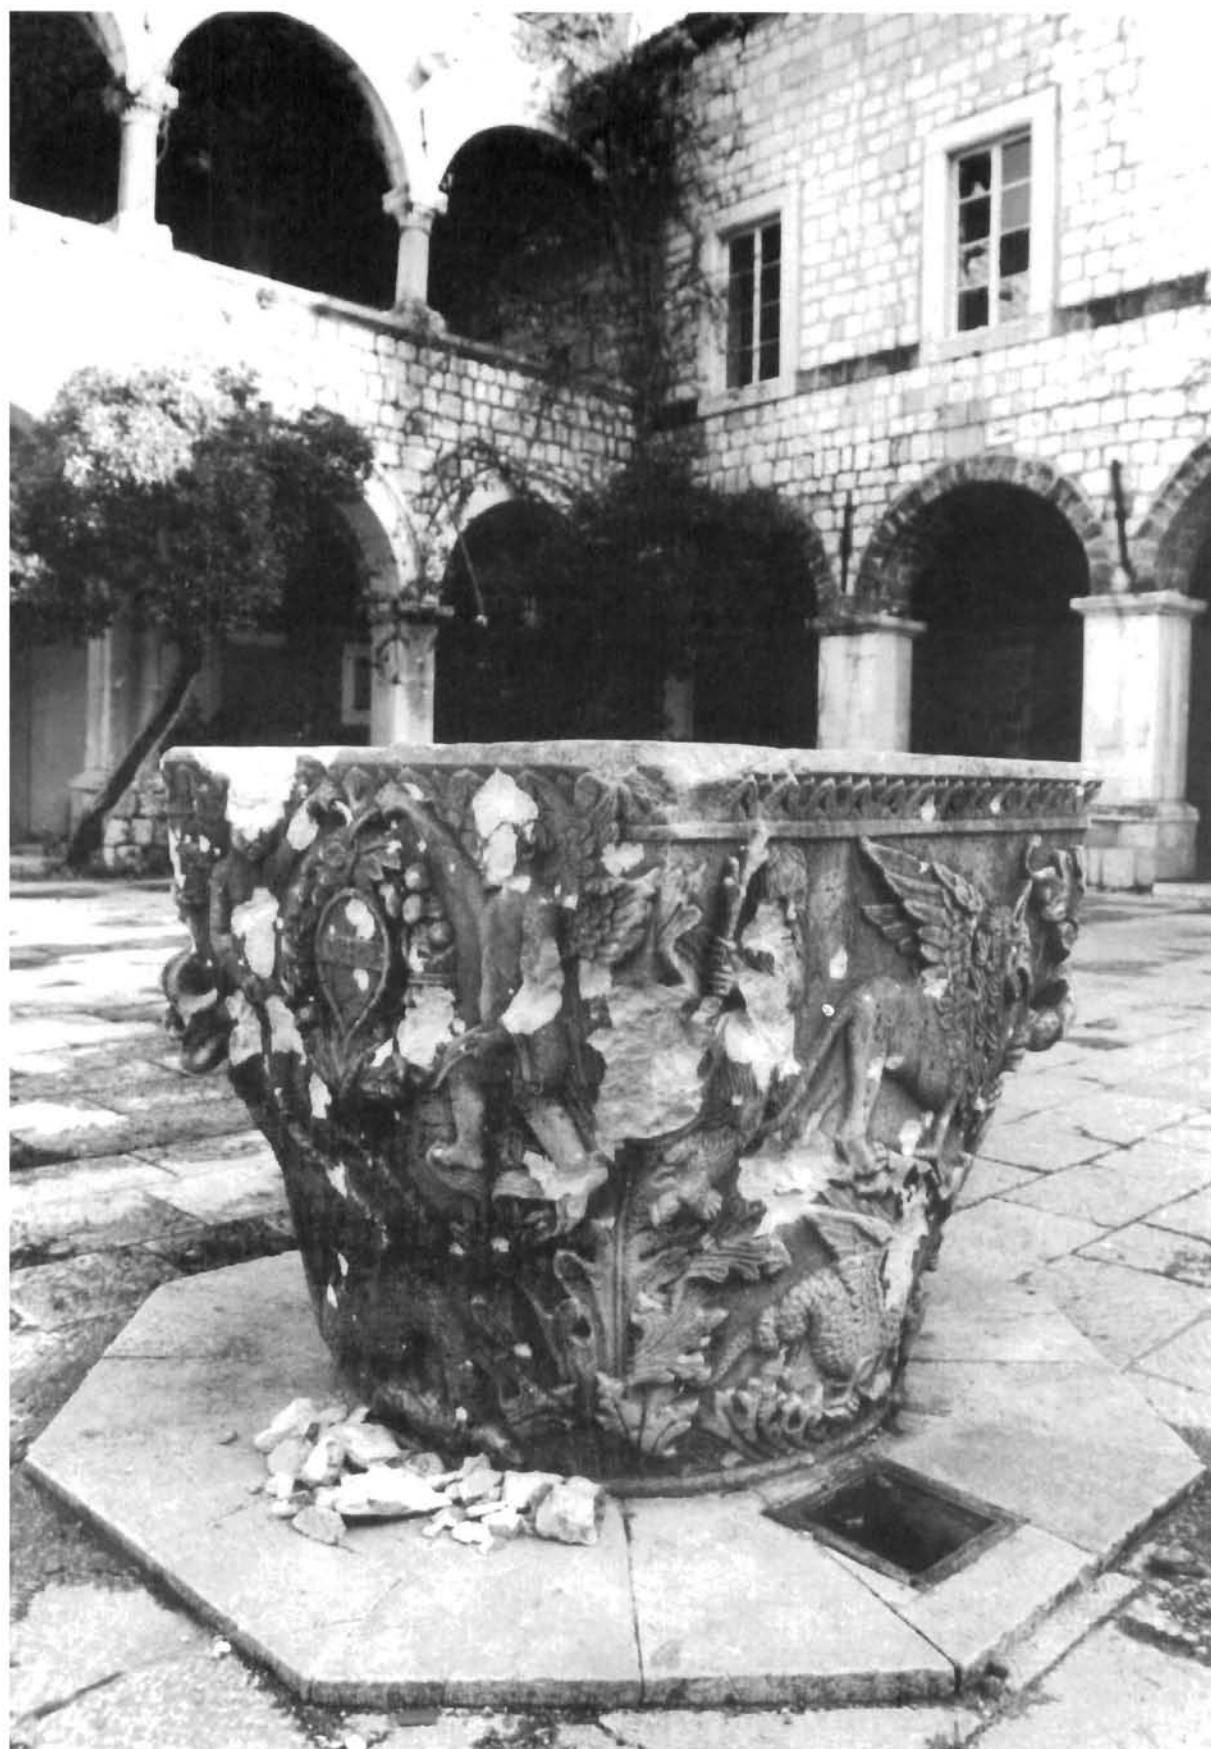
Bivši samostan sv. Klare, kruna bunara (foto: Miljenko Mojaš)
Former convent of St. Clare, crown of the well (Photo: Miljenko Mojaš)

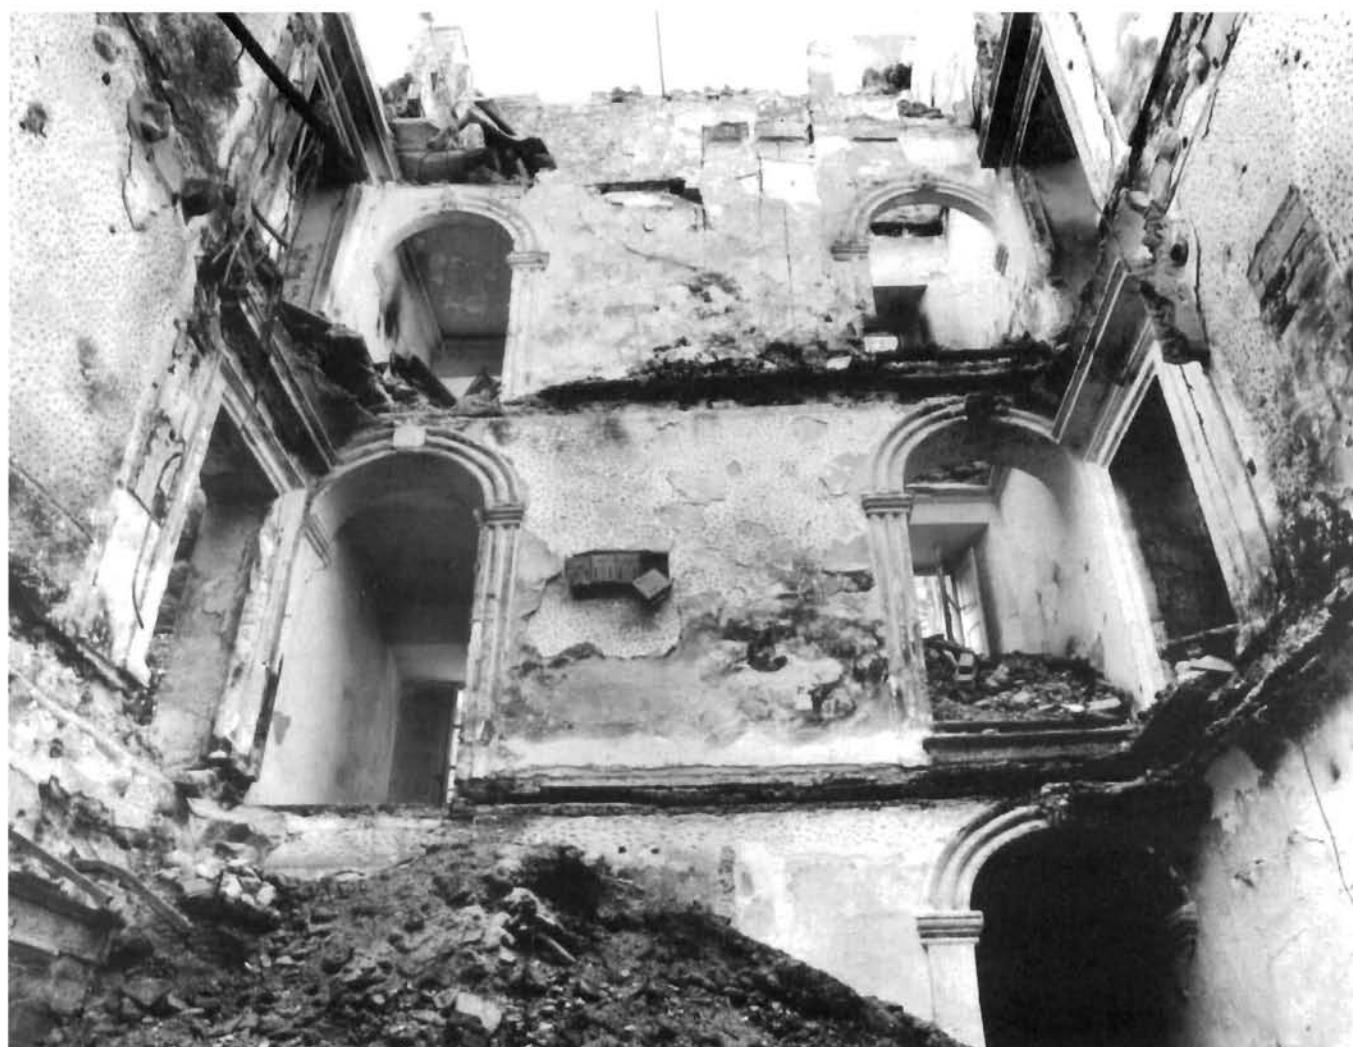
Palača u Ulici od puča 11, unutrašnjost (foto: Miljenko Mojaš)
Mansion in the Street od puča, interior (Photo: Miljenko Mojaš)

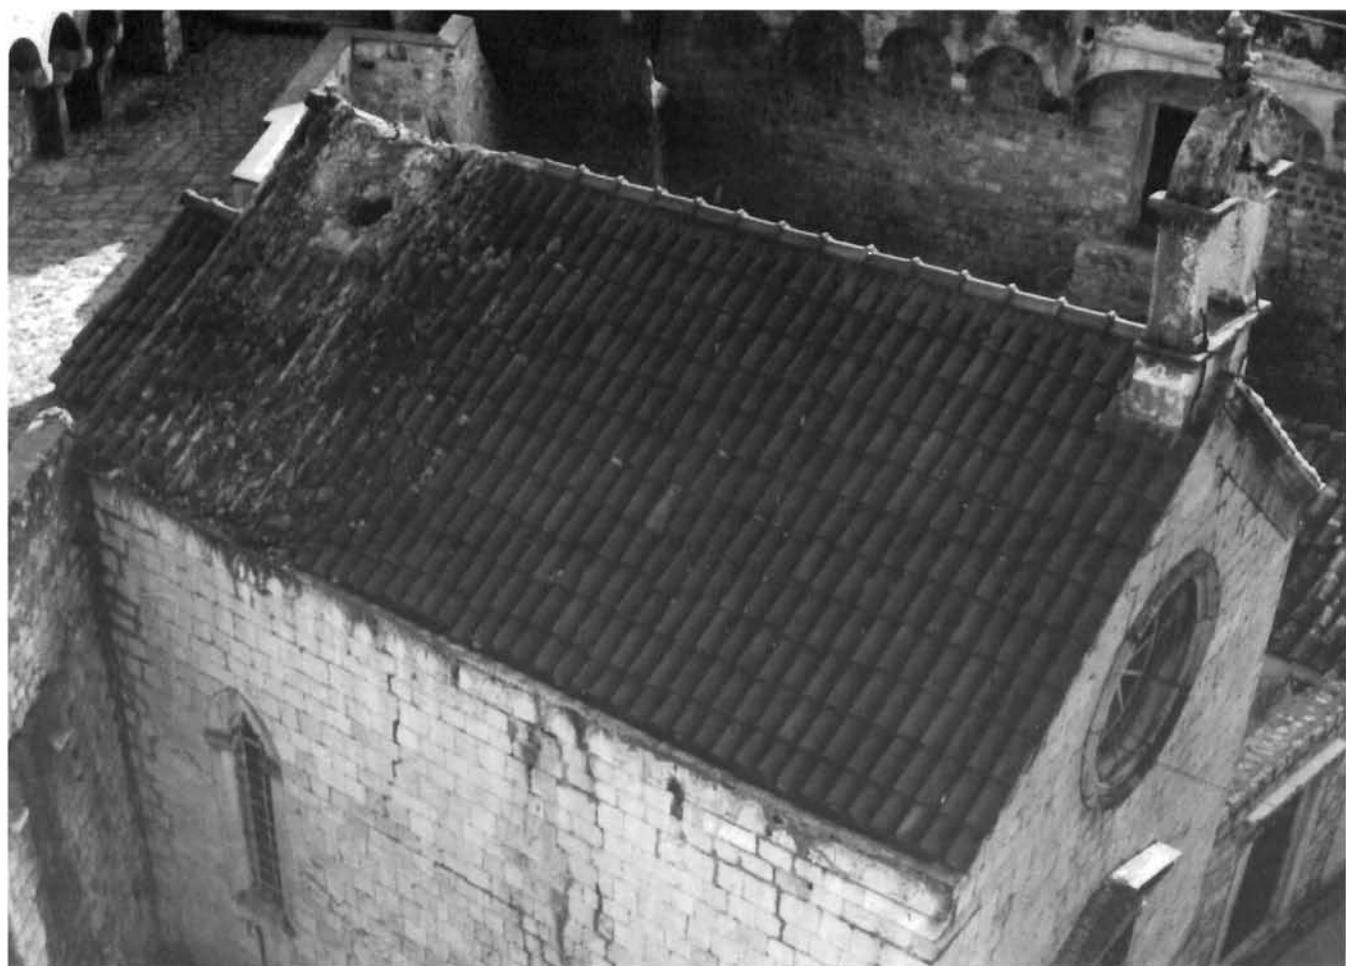
Crkva Navještenja (foto: Miljenko Mojaš)
Church of the Annunciation (Photo: Miljenko Mojaš)

Od neizravnog učinka projektila neznatno je oštećena crkva Navještenja po apsidalom dijelu. U Malom Stonu stradala je gotovo polovica stambenog fundusa. Od javnih objekata devastirane su Slanica, Arsenal i crkva sv. Antuna Opata. Od fortifikacijskog sustava pogodene su tvrdave Koruna, Toljevac (prilog IV) i zapadna kula Lučkih vrata. Dokle ide suludost agresora najbolje pokazuje podatak da se on izvijjava na "dardinima" nadaleko poznatih stonskih kamenica i mušula. Kako zaključiti ovaj tekst kad nemam riječi u kojoj bi sublimirao bolesni um, vandalizam, četnizam i ostale "izme", kada je taj nepostojeći termin, kojega svakako moramo stvoriti zbog naše djece, izvršio genocid, kulturocid, rurocid i urbanoCID nad dijelom južne Hrvatske?!

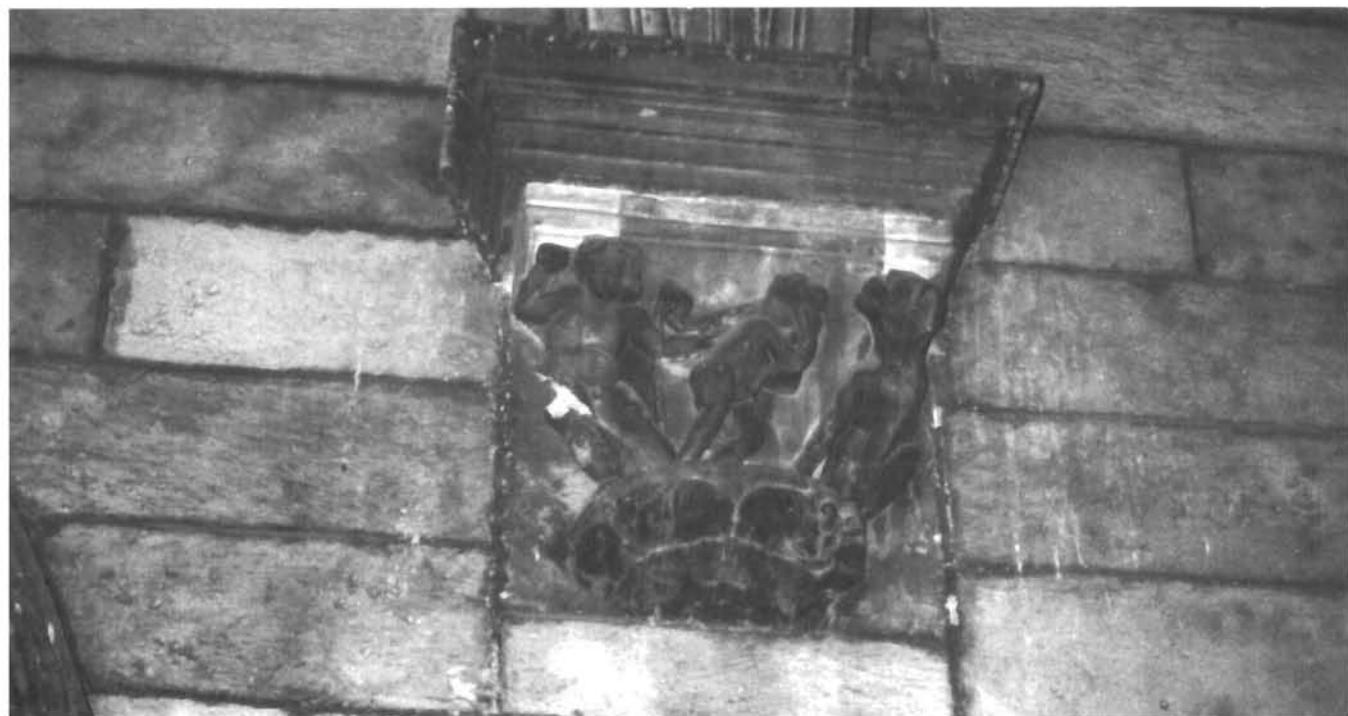
Knežev dvor, konzola trijema (foto: Ivica Žile)
Rector's Palace, console of the arcade (Photo: Ivica Žile)

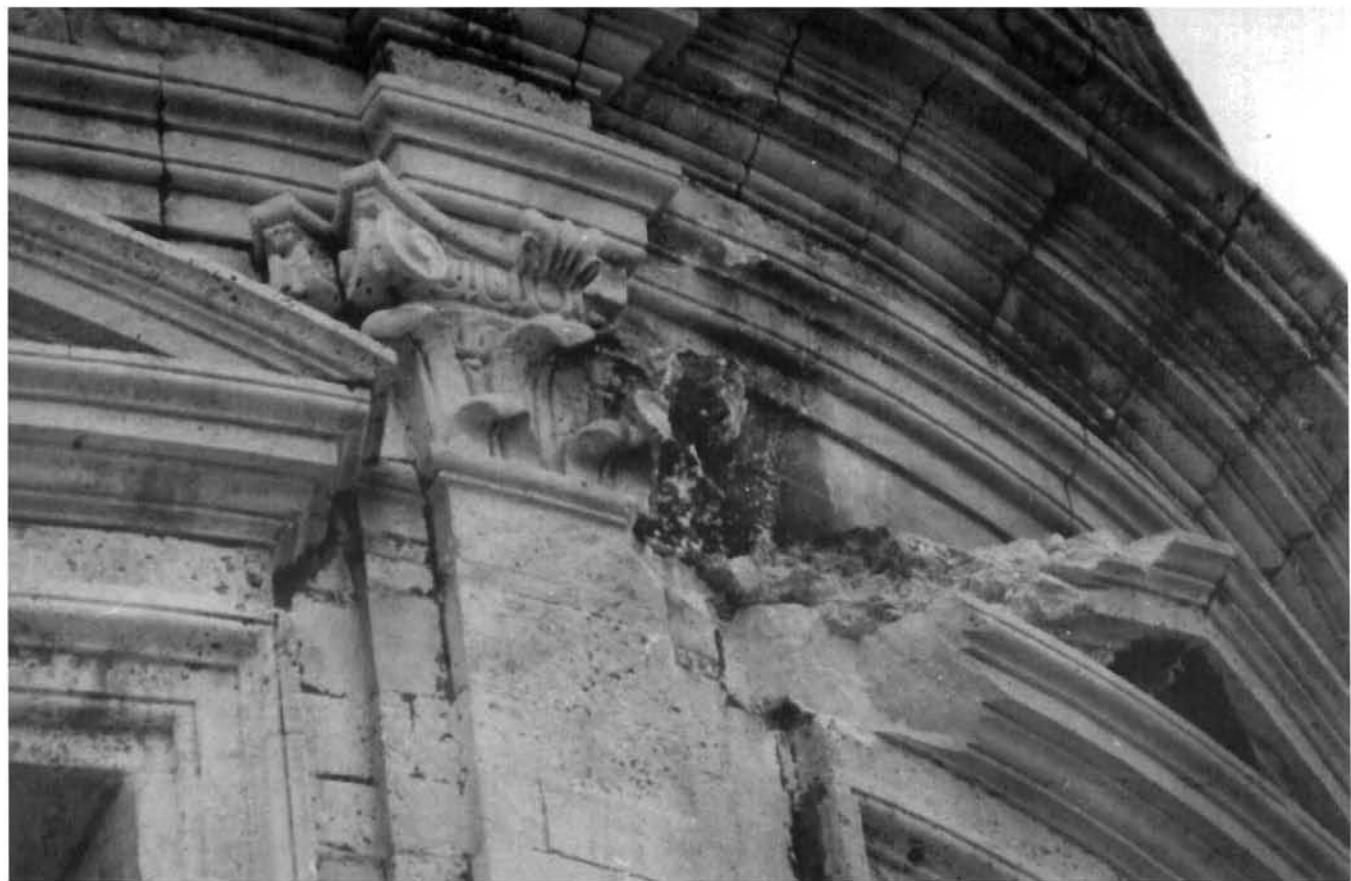
Katedrala, kupola (foto: Miljenko Mojaš)
Cathedral, the dome (Photo: Miljenko Mojaš)

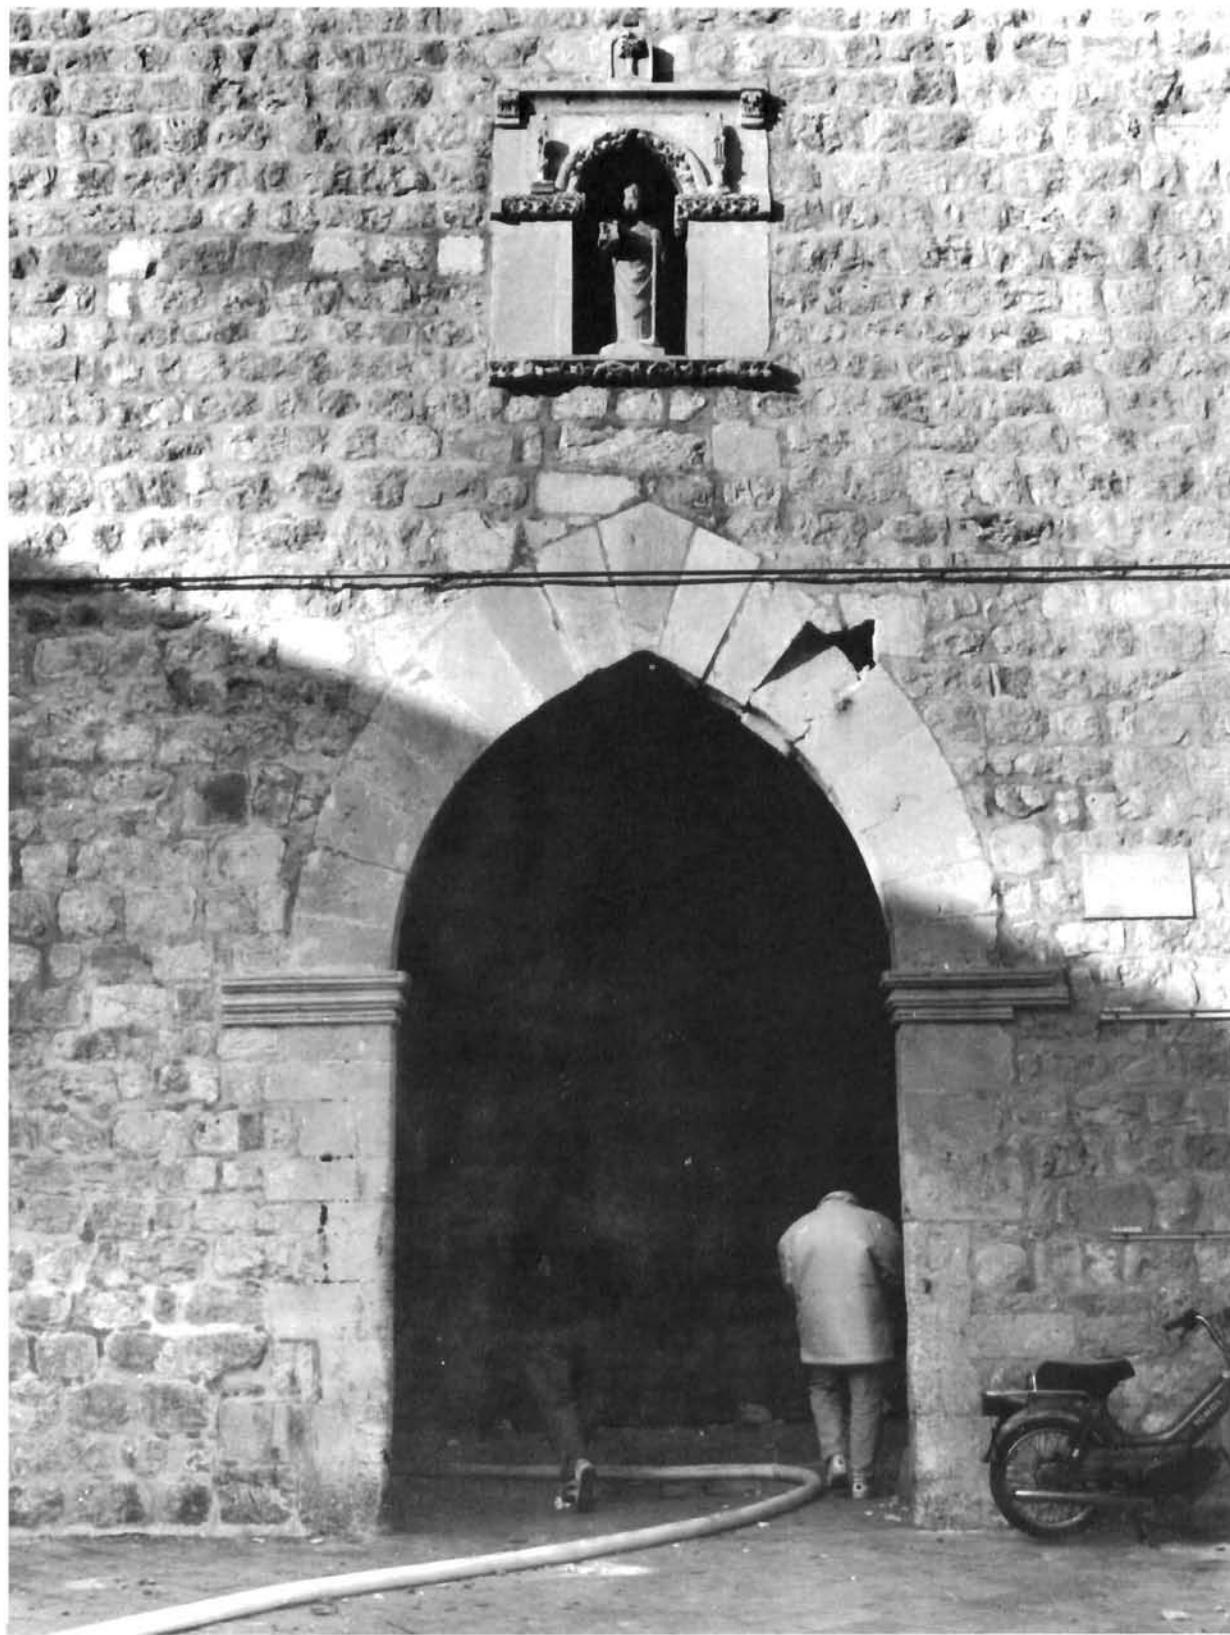
Vrata ribarnice (foto: Miljenko Mojaš)
Door of the fish-market (Photo: Miljenko Mojaš)

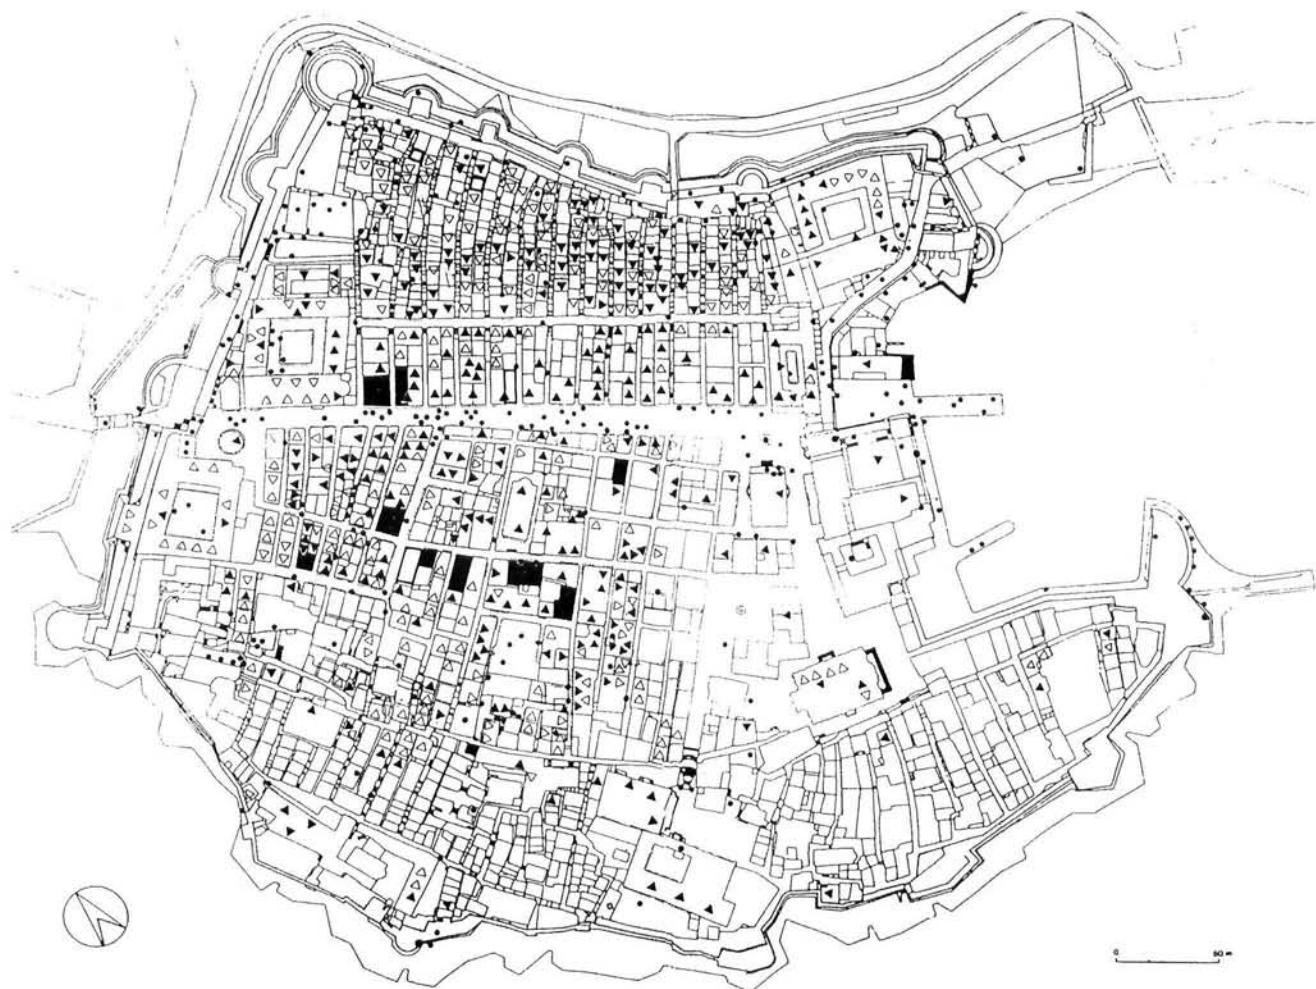
Dubrovnik, objekti oštećeni bombardiranjem 6. prosinca 1991.
Dubrovnik, objects damaged by bombing on December 6th 1991.

Lokacije izravnih pogodaka projektila prilikom bombardiranja povijesne jezgre Dubrovnika
Listopad/studen 1991.

*Location of direct hits during the bombardment of the historic city centre of Dubrovnik
October/November 1991*

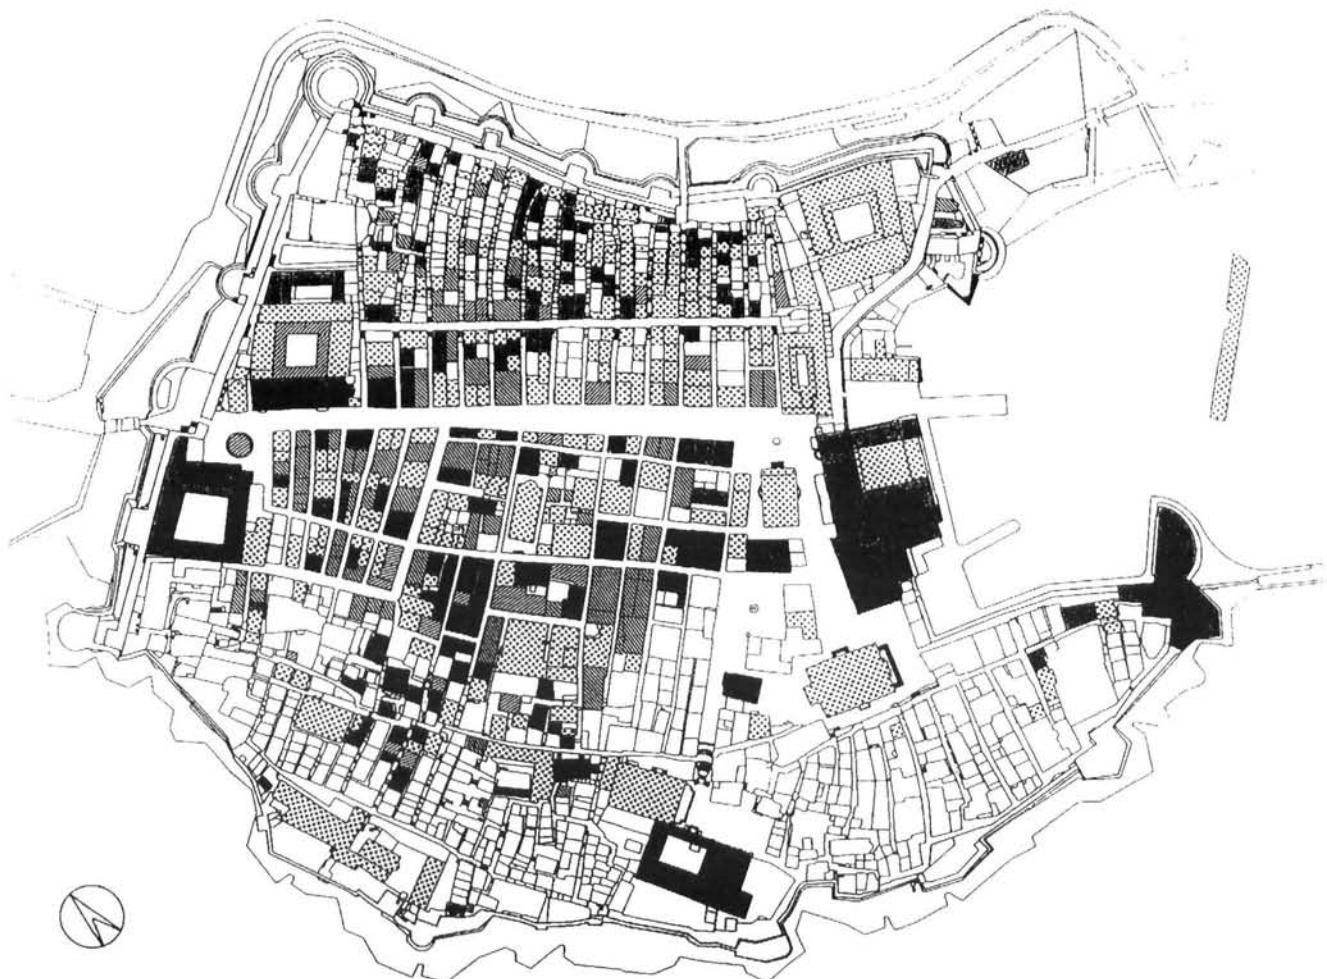
Preliminarno izvješće napravili su stručni suradnici Zavoda uz suradnju s vanjskim suradnicima i konzultantima gospodom Colinom Kaisерom i Brunom Carnezom, predstavnicima UNESCO-a. Rezultati izvješća stravična su slika koju pružaju ubikacije izravnih i neizravnih pogodaka u tlocrt gradske jezgre (prilog II) sa superponiranim kategorizacijom šteta (prilog III).

Kategorizacija objekata oštećenih ratnim razaranjem stare gradske jezgre Dubrovnika - listopad, studeni, prosinac 1991.

Categorization of the objects damaged by the war destruction in the historical core of Dubrovnik - October, November, December 1991.

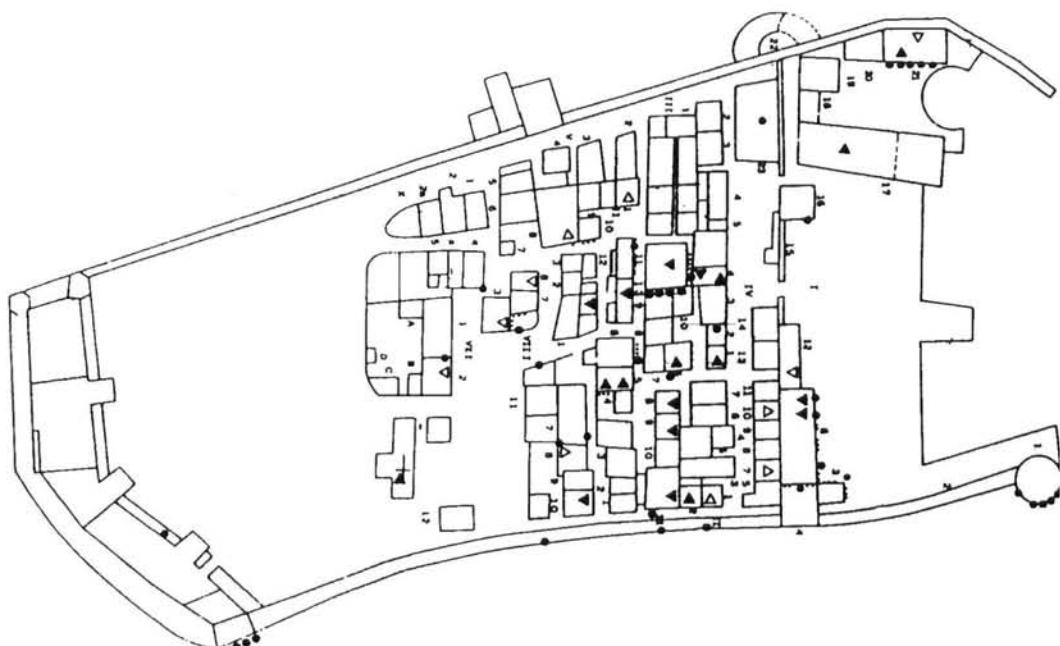
Mali Ston, lokacije oštećenja na objektima stradalim ratnim razaranjem, prosinac 1991.
Mali Ston, sites of the damaged objects destructed in the war, December 1991.

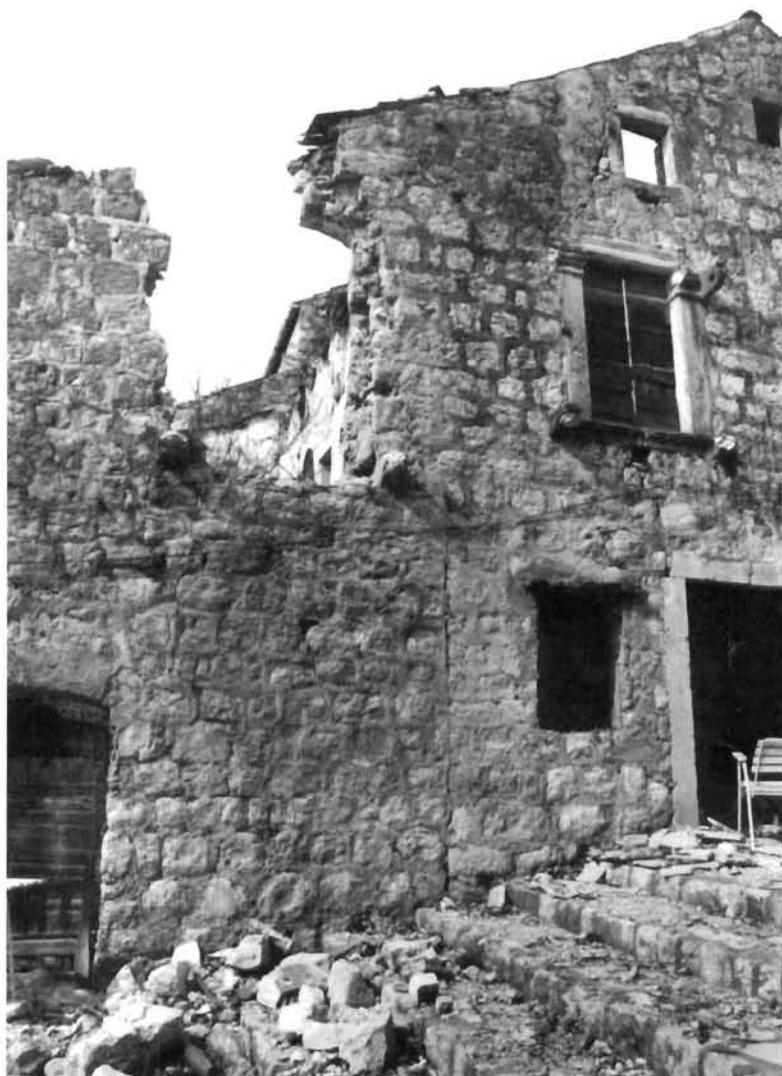
Mali Ston, stambeni objekt (foto: Miljenko Mojaš)
Mali Ston, dwelling house (Photo: Miljenko Mojaš)
